# Matibi Mission Hospital Theatre Renovation Report

Date: June 27th 2025 - Author: Genius Mguni - To: Gertrude Hirzel Foundation

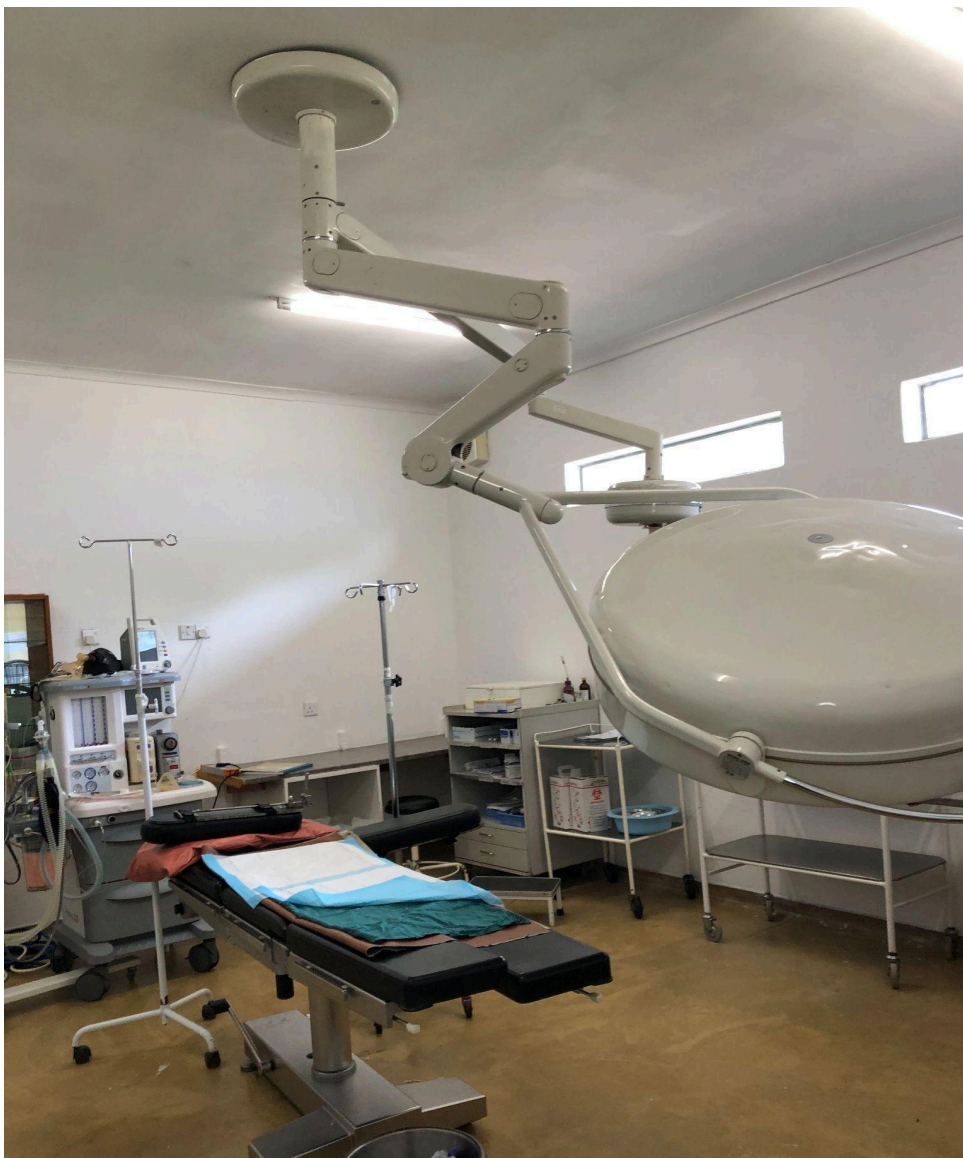
*Theatre room 1*

Both surgical theatres were identified as high-priority spaces requiring structural repair, hygienic improvements, and the replacement of outdated installations. Theatre Room 1 was prioritized for immediate use, while Theatre Room 2 underwent infrastructural improvement but awaits modern equipment to become operational.

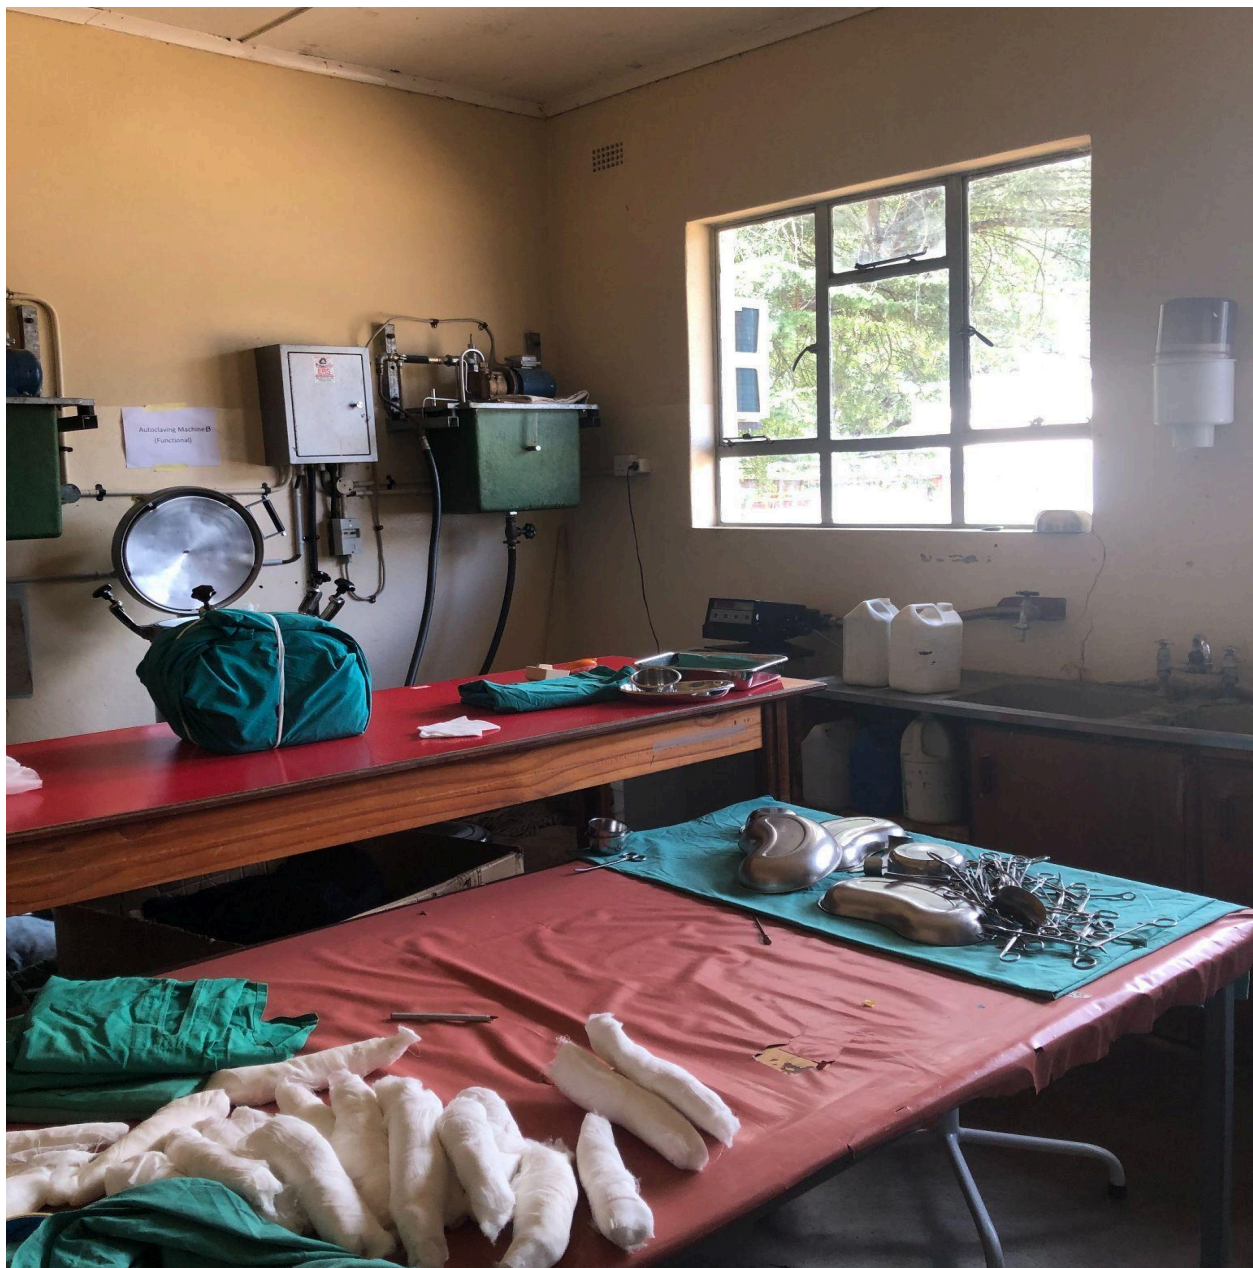
The sterilization room, essential for maintaining infection control, was included in the renovation to ensure compliance with health standards. Plumbing, new fixtures, and finishes were installed to improve sanitation and efficiency.

The sterilization room was fully renovated with upgraded sinks, plumbing lines, painted walls, and vinyl flooring. It is now in operational use and supports surgical services. The sinks that were used might be replaced by types that meet higher medical standards.

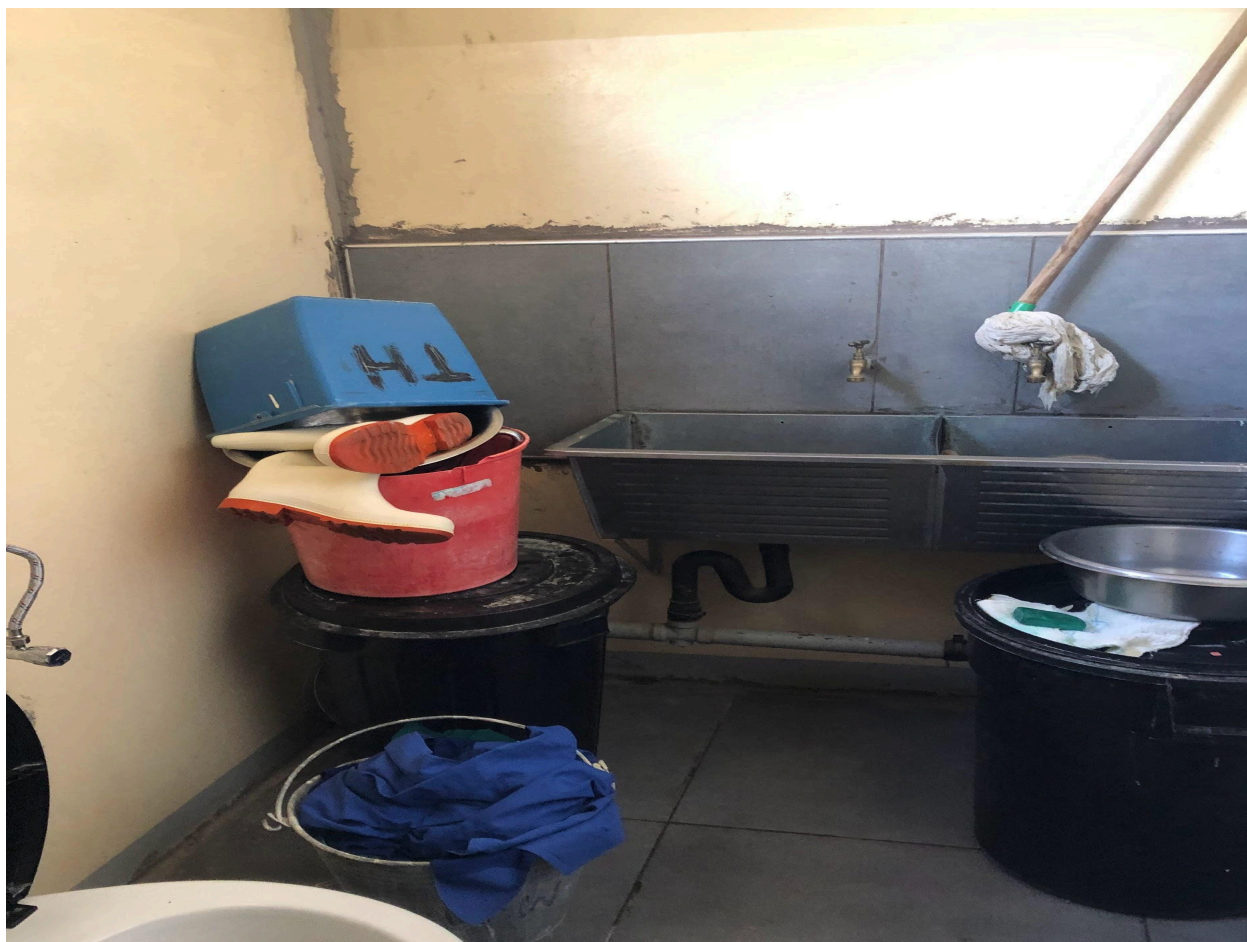
*Sluice Room*

The sluice room was renovated to support the management and disposal of contaminated materials. The works included the installation of a new sink, plumbing enhancements, and interior finishes to bring it to clinical standards.

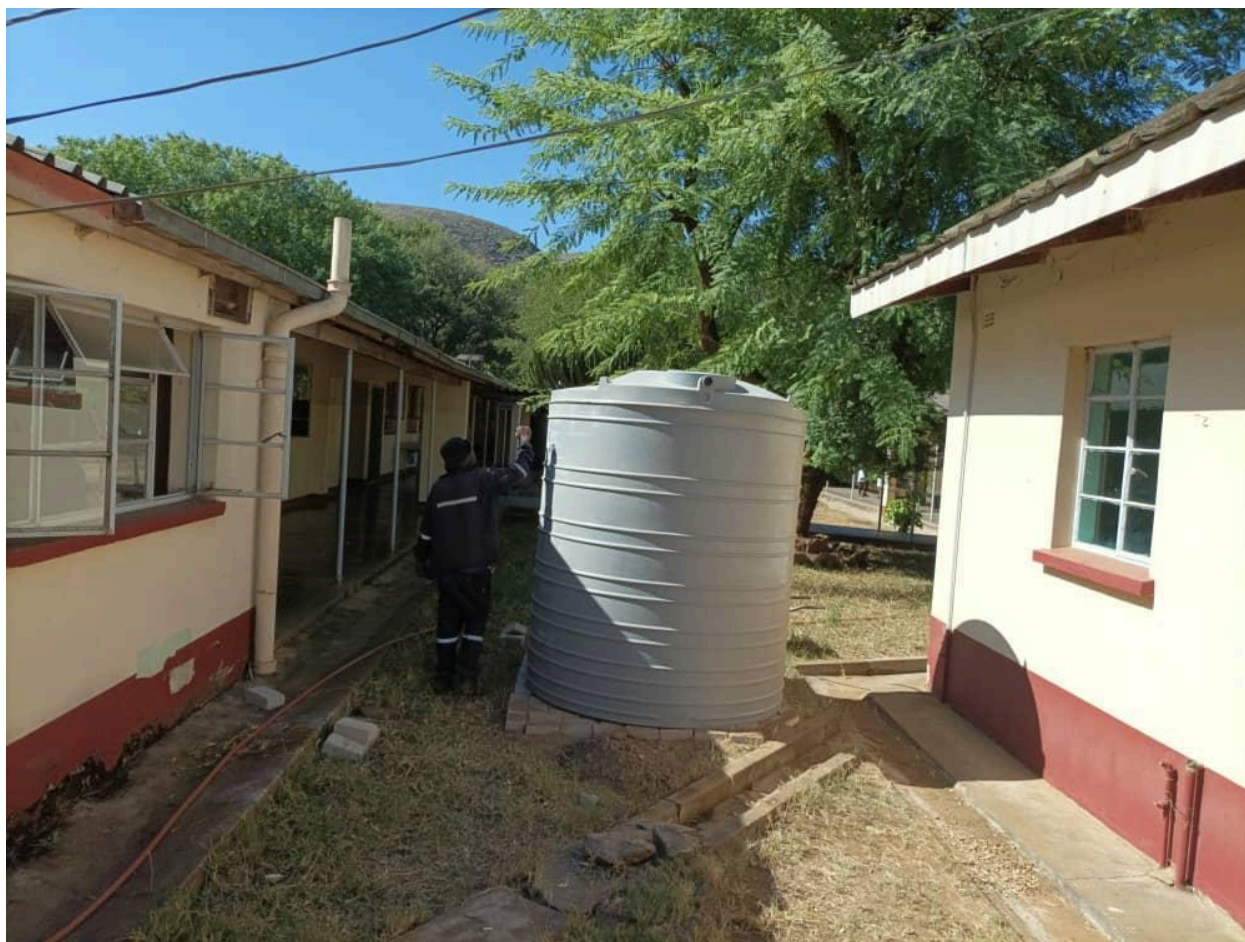
*5000 litres Water Tank*

A new 5000-litre water tank and a pressurized solar geyser were installed to ensure a consistent supply of clean and heated water. These additions are critical for both sterilization procedures and general surgical operations.

- Spring-loaded hinges should be installed on aluminium doors.
- All pillar taps should be replaced with elbow-operated taps to improve hygiene.
- The 20mm PVC pipe at the water tank requires attention and proper installation.

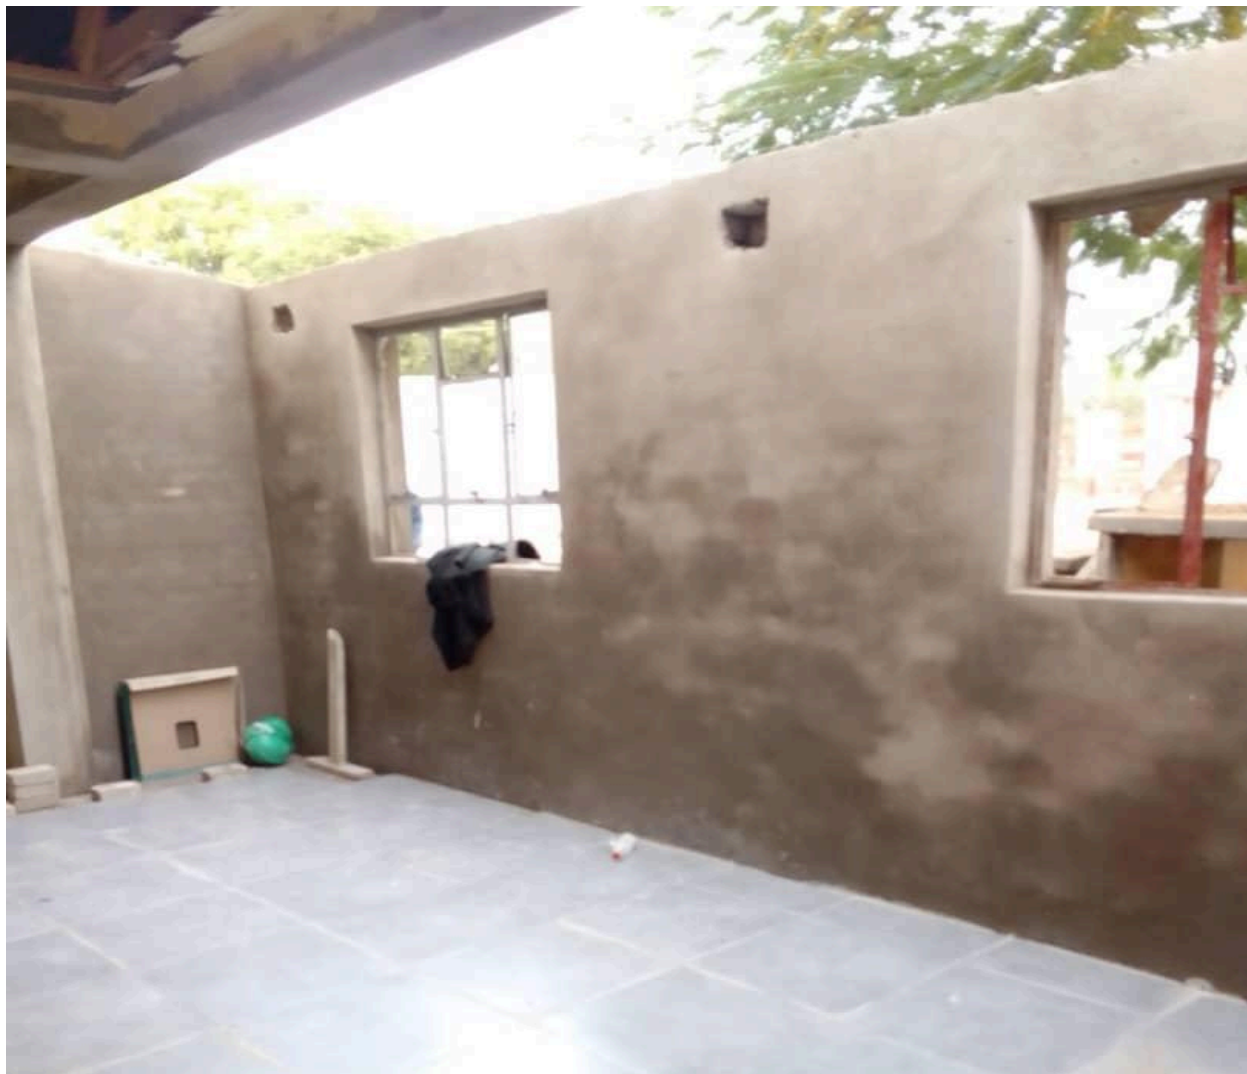
*Wall being rebuilt for extension of recovery area*

Significant work was undertaken to extend the recovery area, including the demolition of an existing wall and the construction of a new one to accommodate the theatre expansion. This resulted in a notable increase in the available floor space within the recovery area.

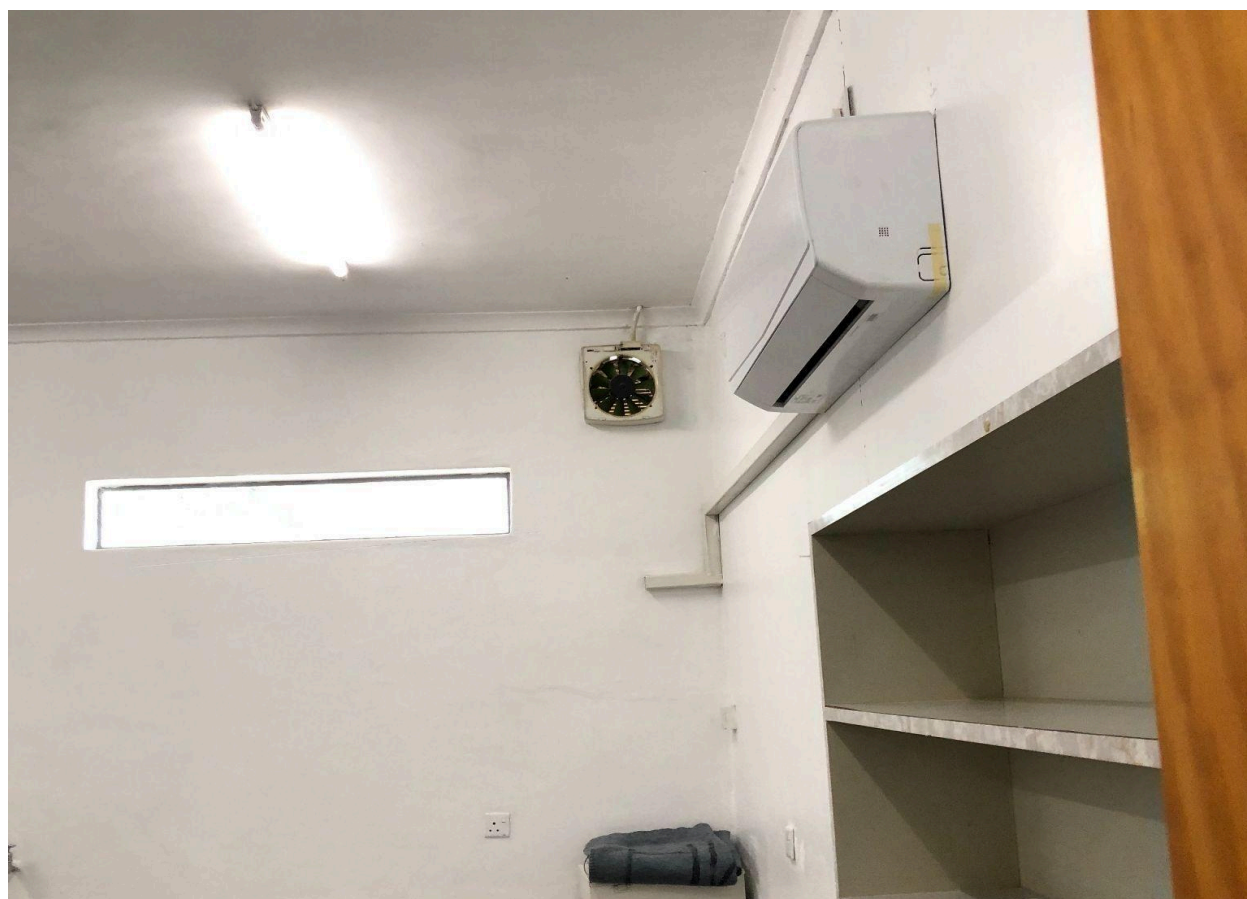
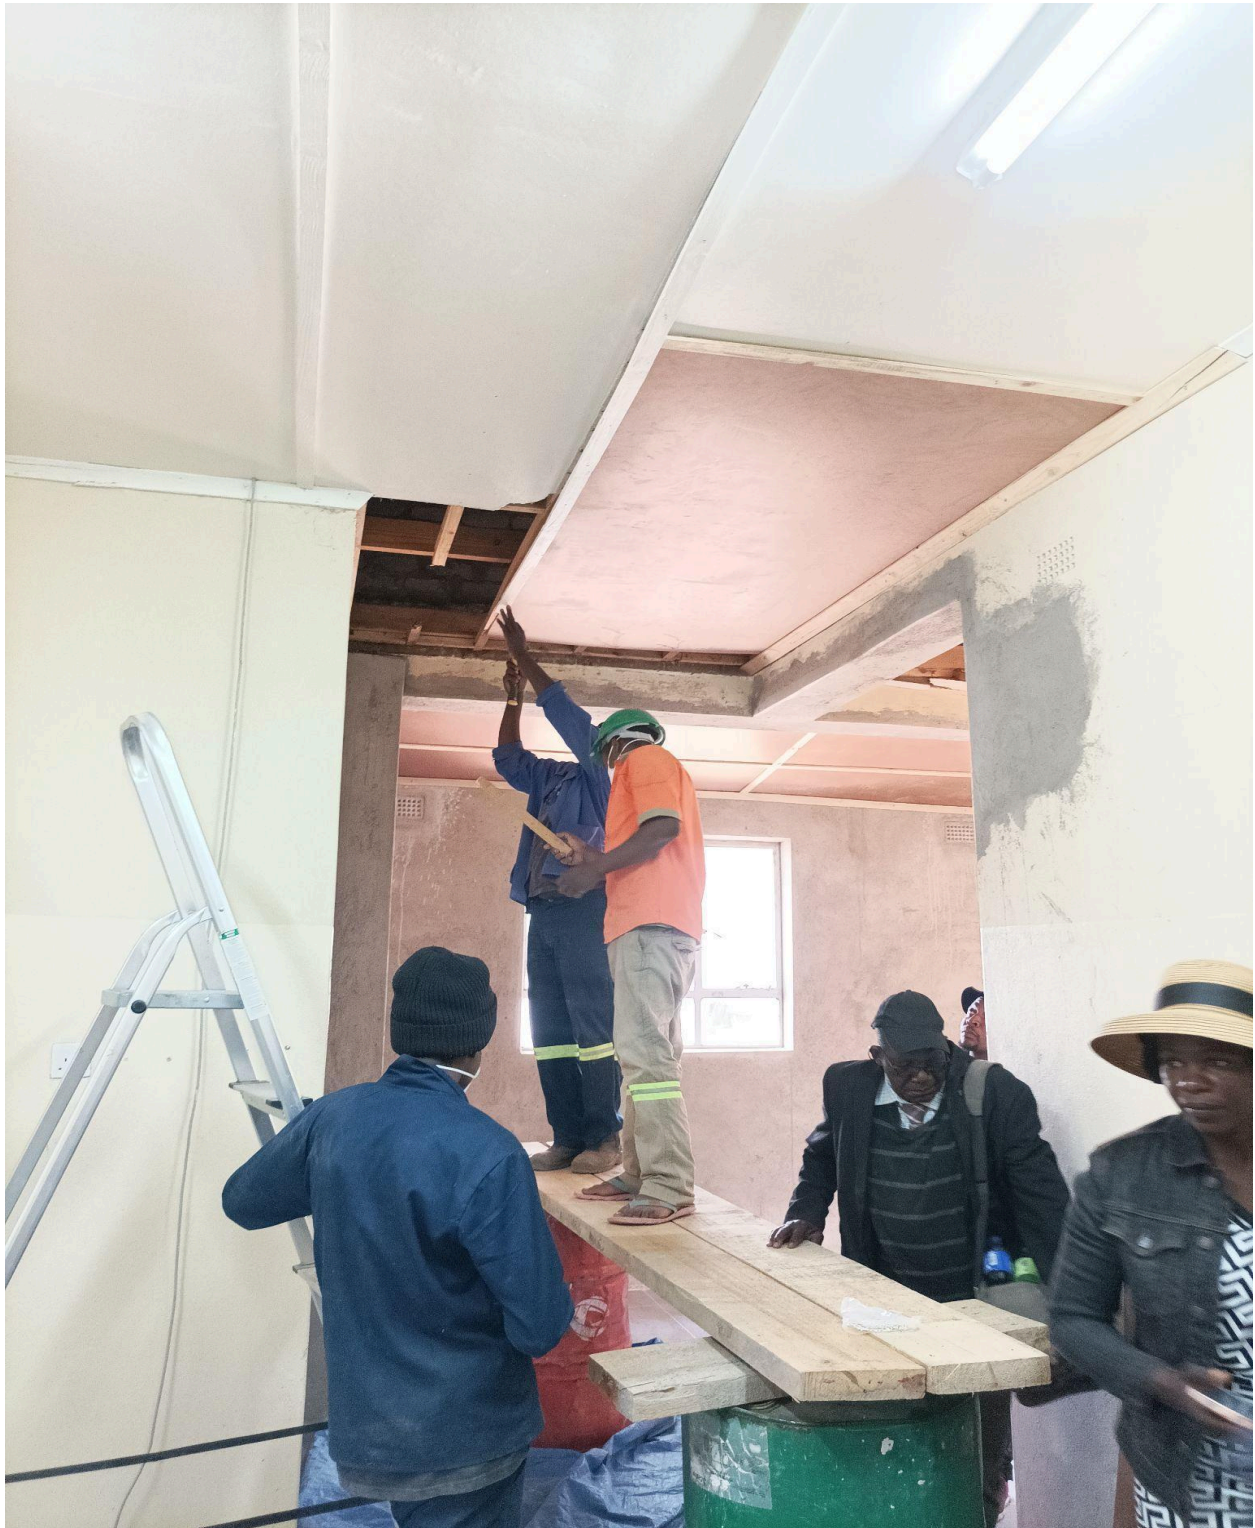
*During Renovations*

New desks, cabinets, stainless steel sinks, taps, plumbing, and electrical fittings were installed across all renovated spaces. These replacements enhance both function and compliance with infection prevention guidelines.

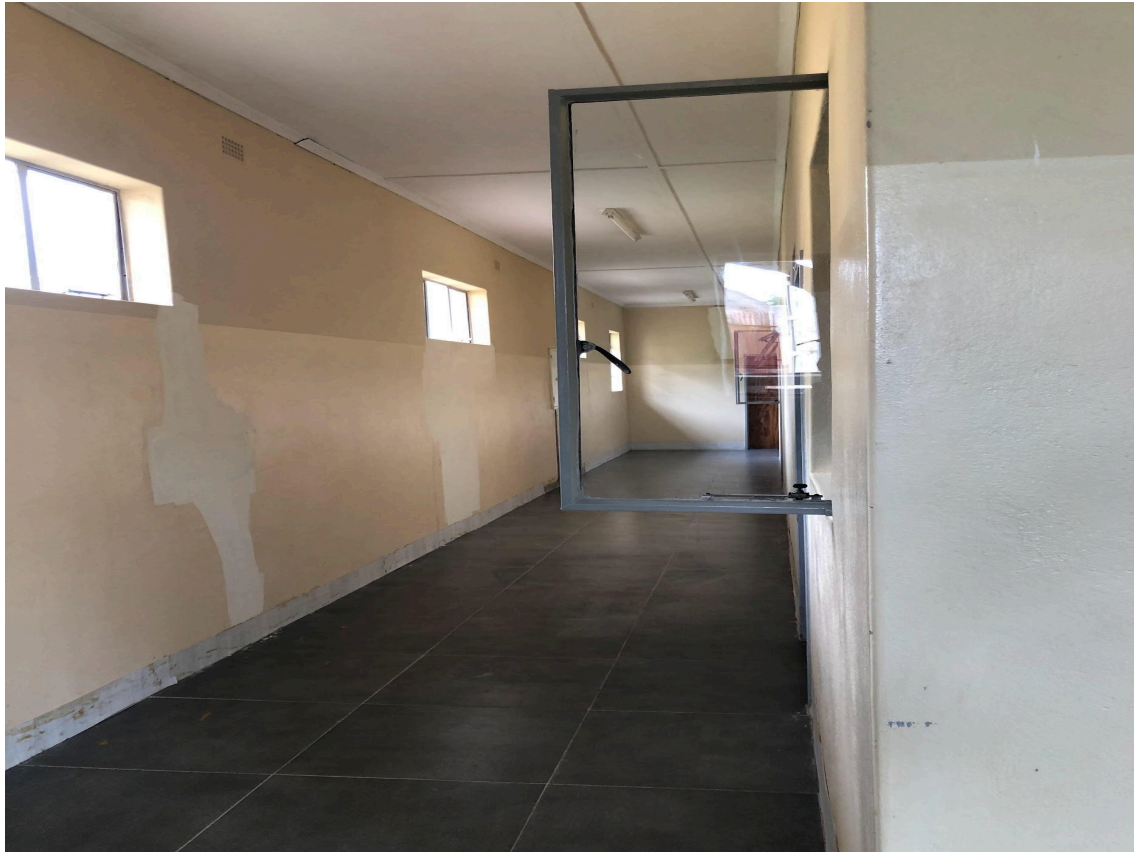
*Tiled floor*

New tiling was installed in the sluice rooms and recovery area. This ensures ease of cleaning and minimizes the risk of microbial contamination.
